**Urgent Field Safety Notice  
Molecular Diagnostics at Abbott**

**Product:** Alinity m System

**List Number:** 08N53-002

December 6, 2021

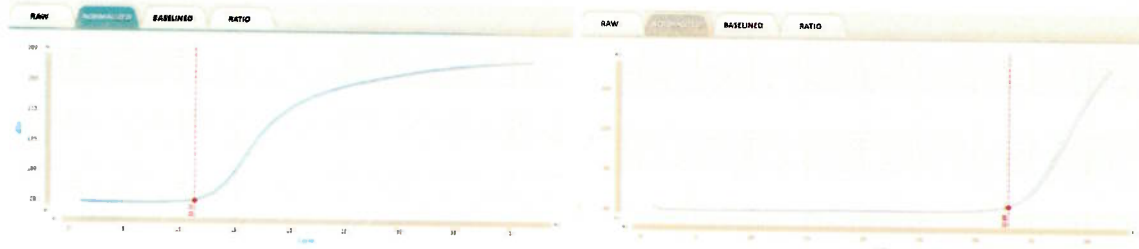
Normal (sigmoidal) PCR curve examples

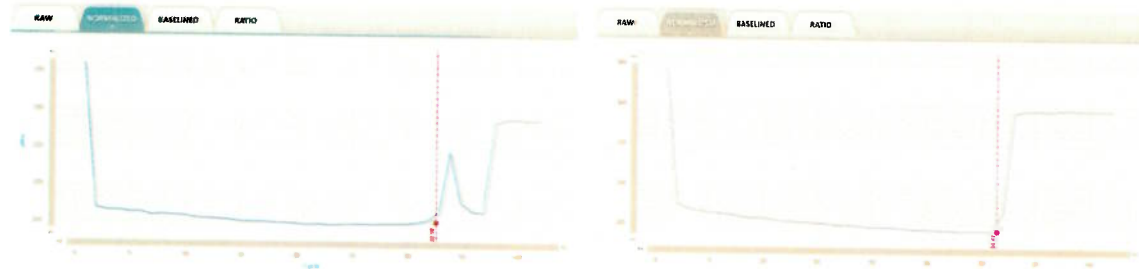
Abbott Molecular Inc. has received two customer reports of Alinity m Resp-4-Plex false positive results and two customer reports of Alinity m STI false positive results due to abnormal amplification curves. Preliminary investigation has identified that the expansion and contraction of air in the Alinity m System Reaction Vessel (RV) during thermal cycling in front of the fluorescent detection window can potentially create air bubbles that interfere with fluorescent readout, resulting in abnormal (non-sigmoidal) amplification curves. Refer to Appendix A for examples of normal and abnormal amplification curves.

Abnormal curves are typically detected by validity checks with assay-specific parameters and are reported as invalids. In rare cases, when an error code is not generated related to the abnormal curve, a false positive result due to abnormal curves may be observed at the following rates: 0.0006% - 0.0012% for the Alinity m Resp-4-Plex assay and 0.00026% for the Alinity m STI assay.

Abnormal (non-sigmoidal) PCR curve examples

Abnormal curves are mitigated in the Alinity m Resp-4-Plex and Alinity m STI assays by adjusting the clamp bar parameters in the Alinity m System. Lowering the clamp bar increases pressure on the RV cap which reduces the motion of air bubbles within the fluorescent detection window leading to less optical noise. This aids in the control of any potential abnormal curves that may lead to invalids and/or false positives for Alinity m Resp-4-Plex and/or Alinity m STI.

As an interim action until your Alinity m System(s) are updated, if a false positive result is suspected including results that have an associated error flag, evaluate the PCR curve generated for the result. Please see Appendix A for examples. If the amplification curve is abnormal (non-sigmoidal), retest the sample. Additionally, repeat tests when two or more analytes (e.g., SARS-
